Settlement Profiling on Losses and Damages Arising from Climate Change Impacts

Case of Nyalenda B and Manyatta B
Informal Settlements in Kisumu County, Kenya.

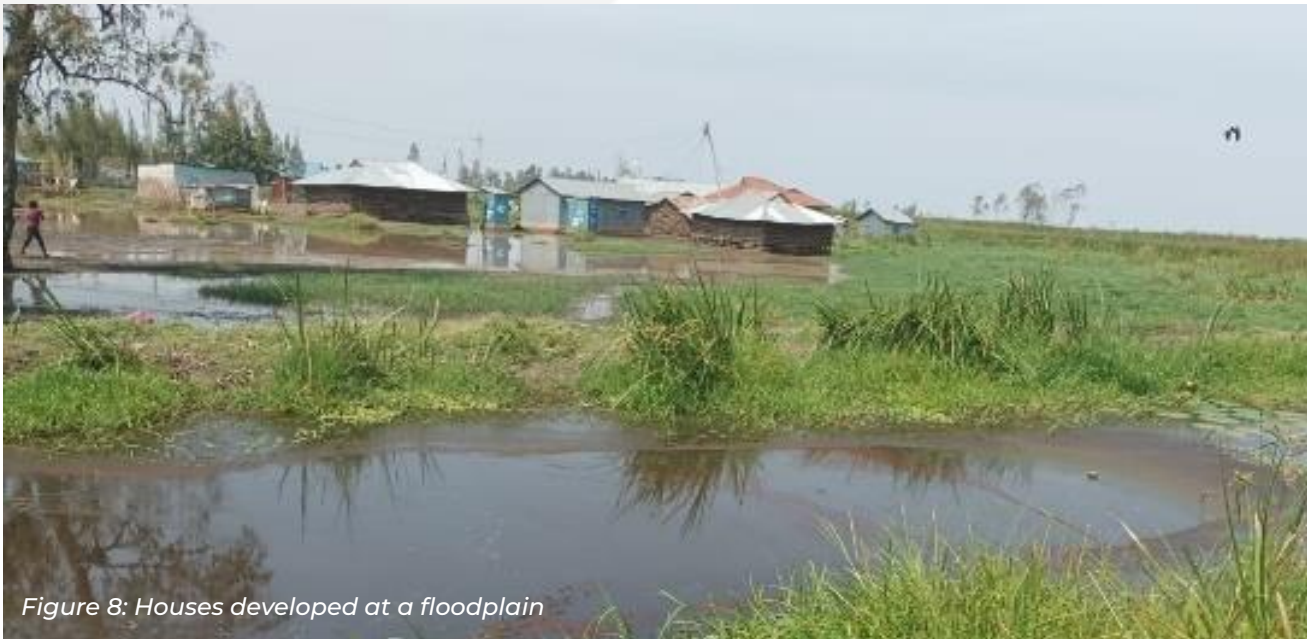
Figure 8: Houses developed at a floodplain

Different individuals have occupied and own the land adjacent to the lake, River Nyamasaria and River Uhuru which was constructed to manage stormwater and overflows of River Nyamasaria. Despite this been an ancestral communal land in the past, a glimpse at the history reveals that the area was initially known as "Dago," meaning waterlogged place. During heavy rains from 1957 to 1963, landowners were forced to relocate to various locations. Once the floods receded, many returned to reclaim their ancestral land, with some rebuilding homes and others selling their land to relocate elsewhere. To date there is human occupancy in the flood plains and wetlands which has increased the people's exposure to flood hazards. Figure 6 below shows the distribution of wetlands in the settlement.

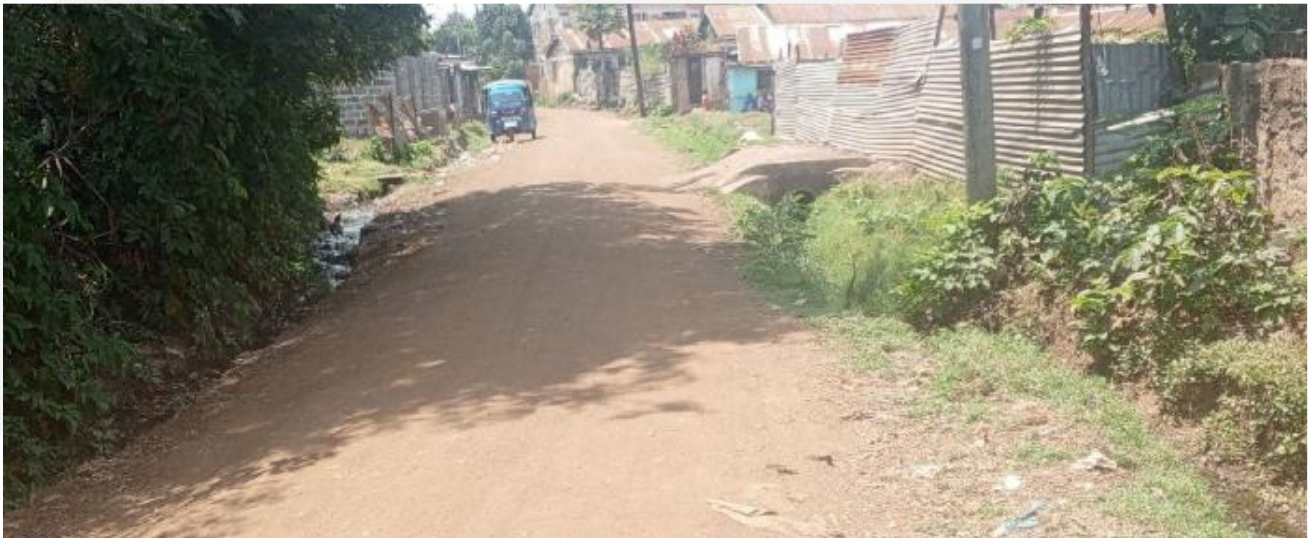
Figure 11: Status of Nyalenda B roads

As shown on figure 10 above, major access road within the settlement is Dunga Road which is well tarmacked. The rest of the access roads are murram roads which are in poor condition, affecting mobility and access to marketplaces, educational facilities, health care facilities, particularly during the adverse weather conditions such as heavy rains.

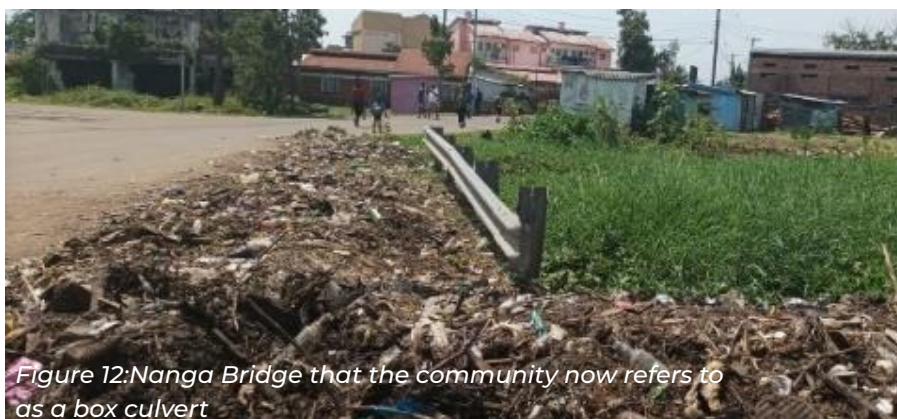
Figure 12: Nanga Bridge that the community now refers to as a box culvert

Nanga bridge is the main bridge that provides access across river Wigwa. The bridge is however in the form of a box culvert that is often flooded as it causes obstruction and also contributes to increased water backflow, leading to heightened flooding. The flow of river waters is blocked at the bridge due to accumulation of solid waste at the riverbed as well as siltation and water hyacinth. If the bridge had been well constructed and raised, the blockages would not be present. The other bridges along river Wigwa are temporary bridges that requires upgrade to enhance accessibility and connectivity especially during the rainy seasons.

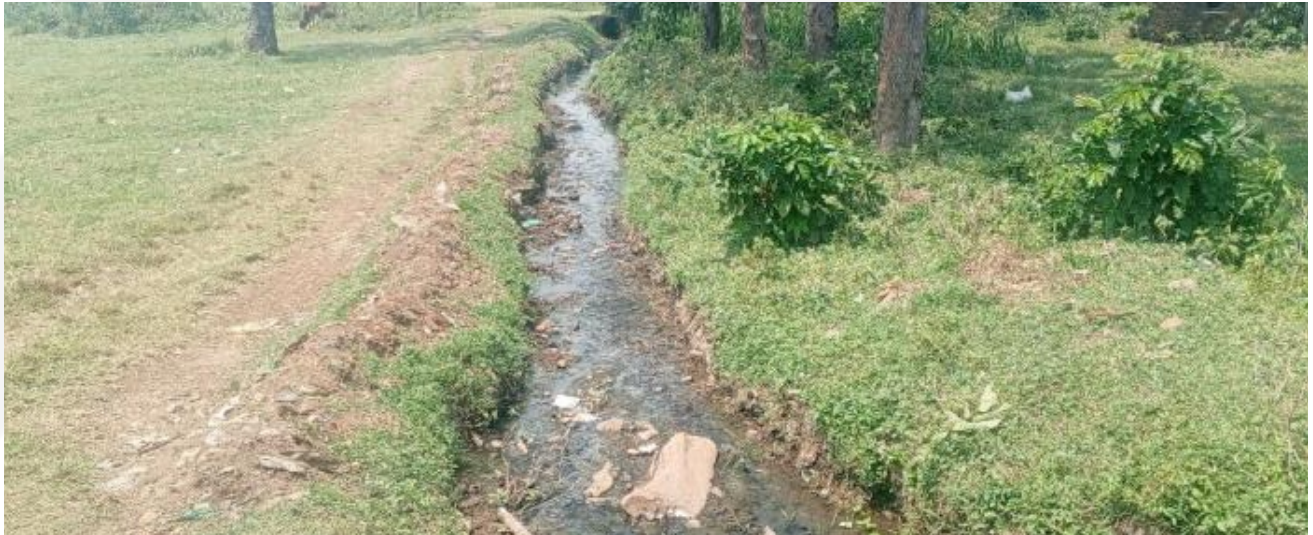
Figure 13: Existing dug up water drainage channels

The main storm water drainage system in the settlement and a better part of the city channels water to River Wigwa and Nam Thoi swamp which abuts the ward. Some of the housing structures are located near drainage channels and are worst affected during rainy seasons. There is need to have proper maintenance of the storm drains to enhance flow of rainwater during the rainy seasons and curb flooding.

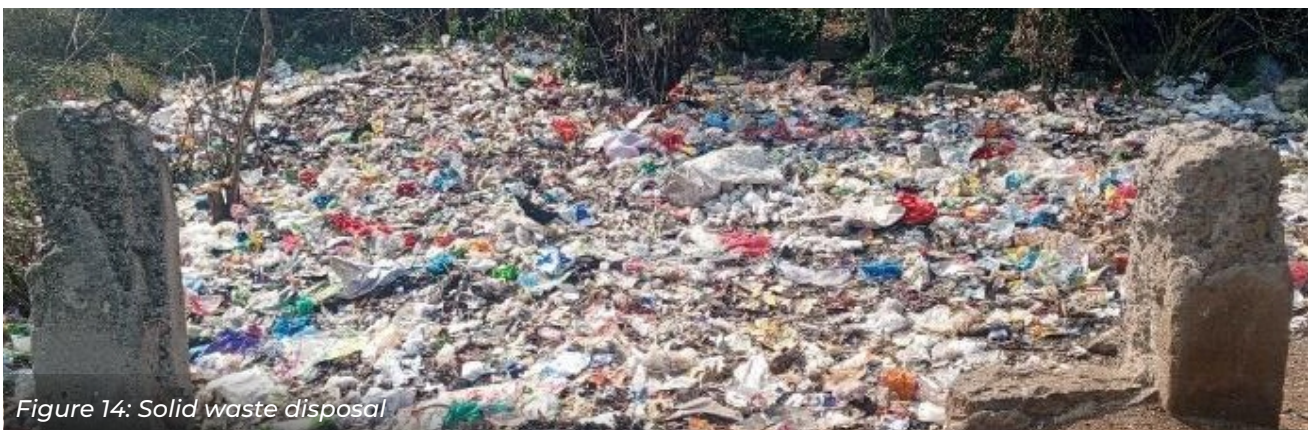
Figure 14: Solid waste disposal

There is poor solid waste management in the ward. Most waste are disposed at illegal and informal waste disposal sites within the neighbourhood which worsen the state of sanitation and hygiene in the settlement. During the rainy season the poor solid waste management and flood waters lead to spread of water borne diseases. 40% of the respondents confirmed that they have access to solid waste collection point while there is only one designated waste collection point with a waste skip within the settlement. The rest of the waste is dumped at informal and illegal locations.

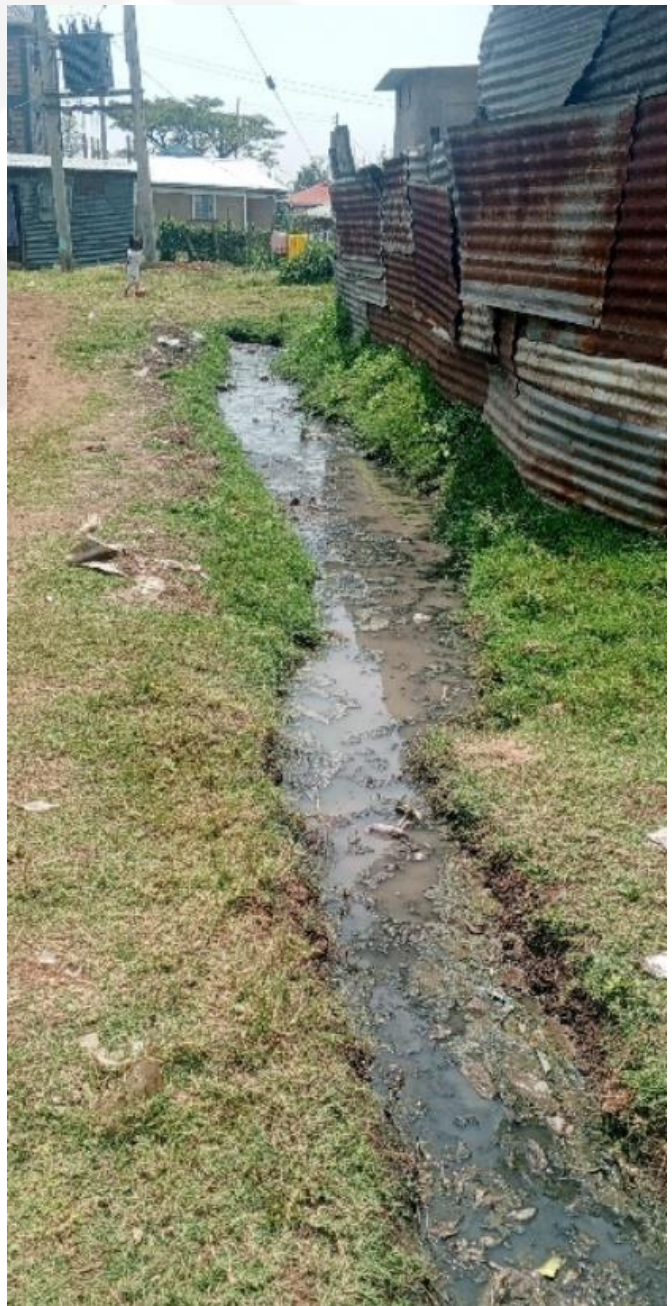
Figure 15: Liquid waste disposal

Despite a major city sewer line cutting across the settlement and liquid waste disposal been done at River Wigwa, Nyalenda B settlement lacks a sewerline. As a result, households release liquid waste in River Wigwa. During flooding events, households in the settlement are exposed to water borne diseases.

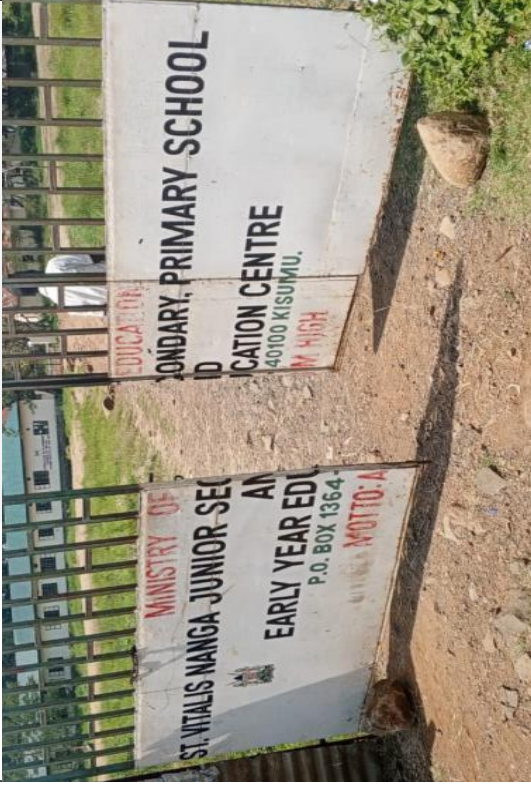
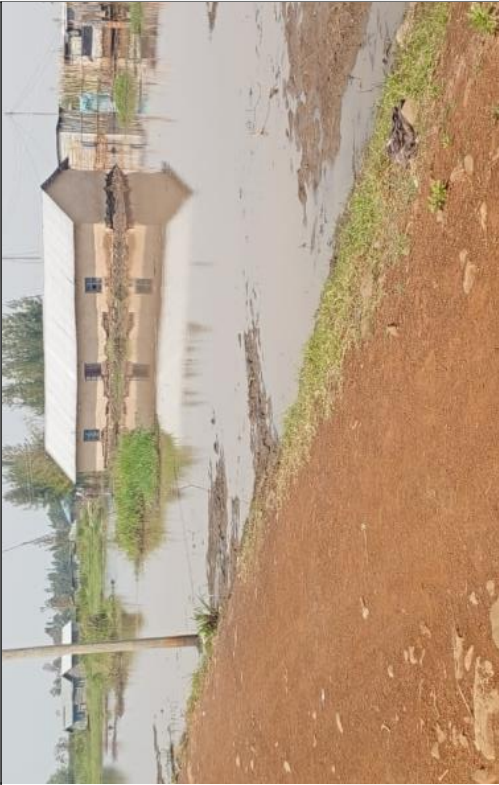
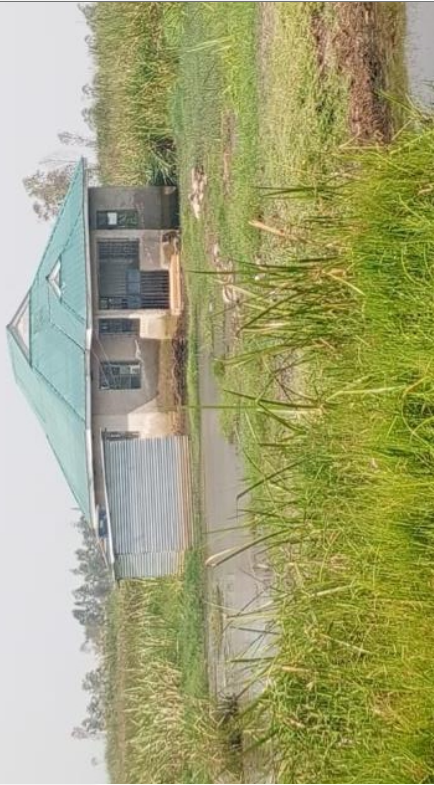
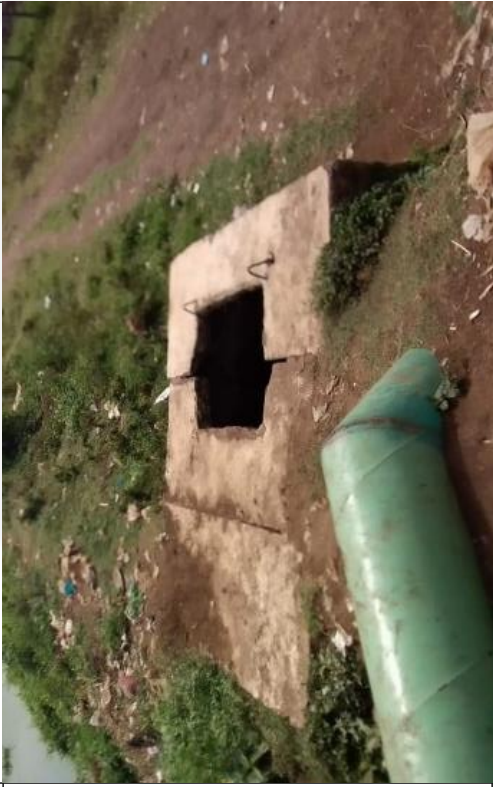
Housing	<p>73 homes destroyed by the flooding events.</p> <ul style="list-style-type: none"> · Brick, mud and wattle houses around Nanga Kapuotho destroyed. · At dunga: houses were submerged along kiboko bay and board walk. · Part of kilo: some of the houses are affected by water and some destroyed. 	<p>a) Permanent houses partially destroyed.</p> <p>b) Sinking/ submerging of houses</p> <p>c) Cracking of houses</p> <p>d) Semi-permanent and mud and wattle homes completely destroyed.</p> <p>e) Toilets were also destroyed in this process.</p>

<p>· This happened across the entire settlement</p> <p>Households toilets were partially destroyed.</p> <p>· This was mainly at Nanga Kapuotho</p>	<p>Toilet structures were completely destroyed.</p>	 
<p>Transportation</p>	<p>8. Murrams roads were partially destroyed. this included:</p> <ul style="list-style-type: none"> · Kapuotho - nanga bridge road · Block – 	<p>a) Some of the existing tarmacked roads remained flooded for an extended period, which caused the road infrastructure to loosen and deteriorate.</p>

<p>kobunga road</p> <ul style="list-style-type: none"> · Impala – hippo road. · Nanga bridge-shakeel bridge road · Covenant road · Got-owak – 5 ways roads · Western-wigwa road · Dunga – kasarani road. <p>3 foot bridges partially destroyed</p> <p>Uhuru -ridge</p> <ul style="list-style-type: none"> o kajakambare bridge Aleowra bridge 	<p>b) All weather roads structures in the settlement were weakened making them more susceptible to damage from vehicle and human traffic.</p> <p>c) Degradation and collapse of foot bridges after the rotting of the structure.</p>	
--	--	---	--	--

Energy and electricity	<p>5 electricity poles and 3 flood lights partially destroyed.</p> <p>These were:</p> <ul style="list-style-type: none"> · Kapuotha flood light · Victory floodlight <p>Dunga flood light</p>	<p>b) All weather roads structures in the settlement were weakened making them more susceptible to damage from vehicle and human traffic.</p> <p>c) Degradation and collapse of foot bridges after the rotting of the structure.</p>	 
------------------------	---	--	--

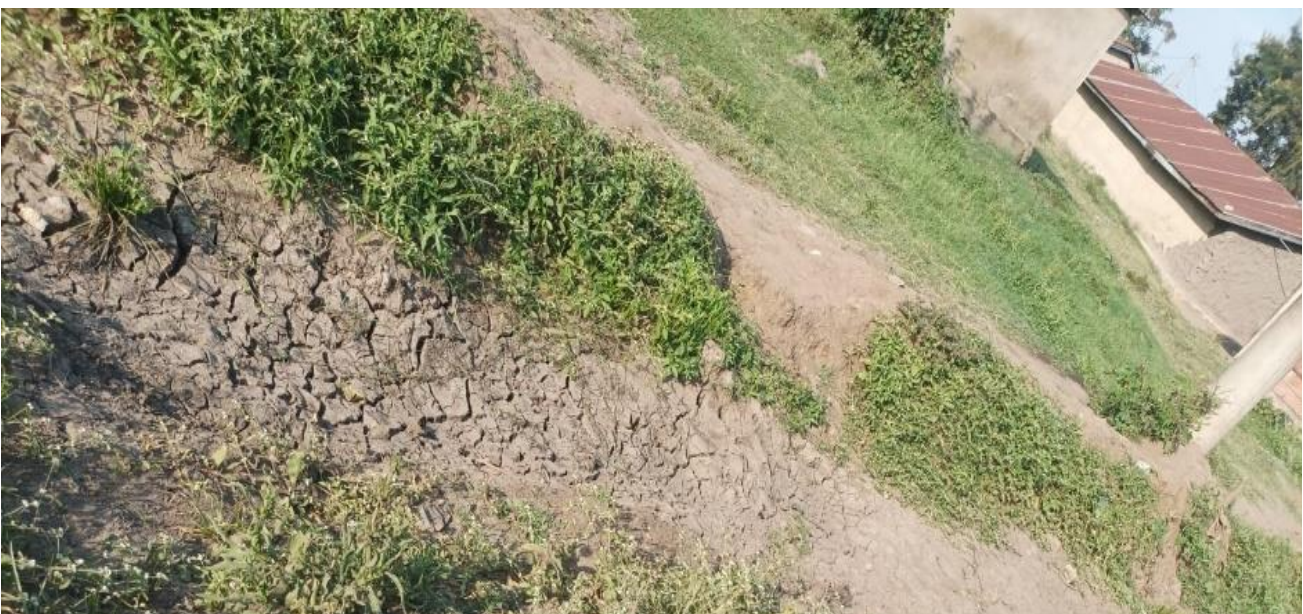
Figure 24: Image of cracked clay soil

Manyatta B's soil is predominantly clay, which retains water effectively. This characteristic increases the likelihood of flooding occurrences, making the settlement more vulnerable to climate change impacts. The clayey soil's inability to drain excess water exacerbates flooding during heavy rainfall, leading to hazardous living conditions and heightened exposure to related risks.

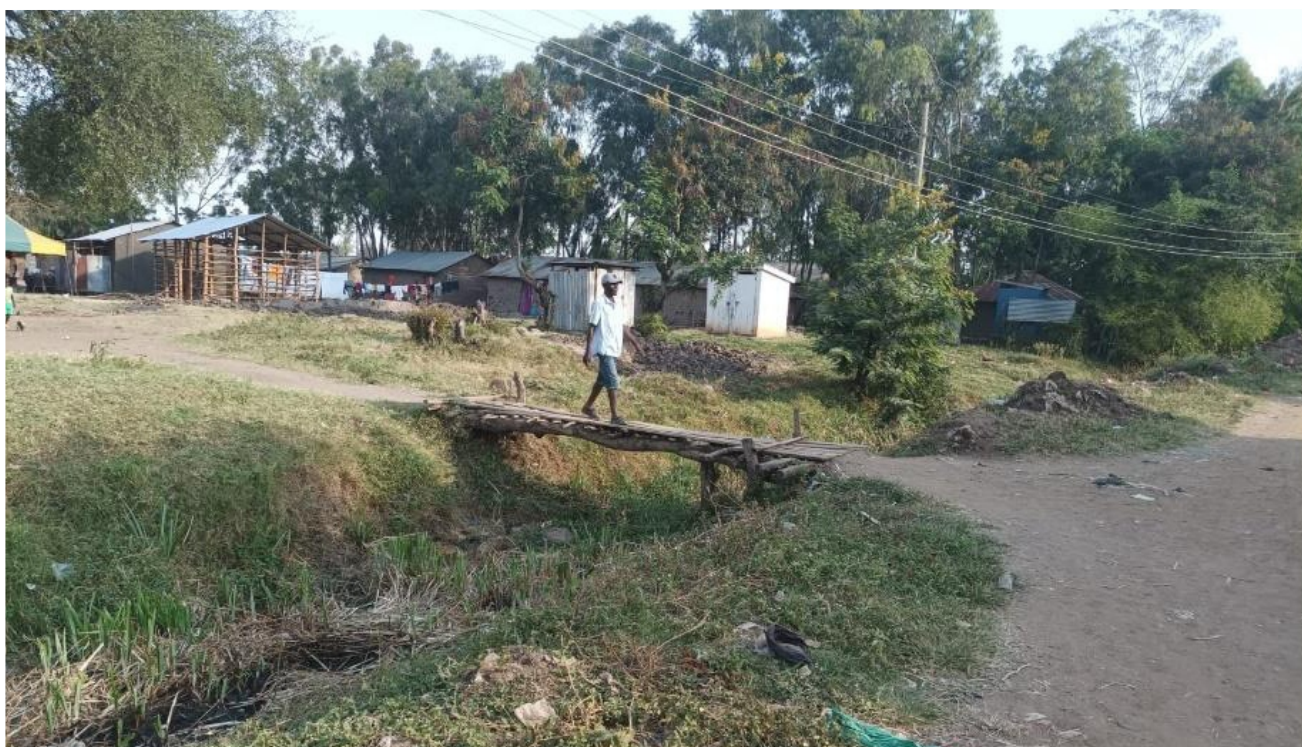
Figure 26: Image of bridge in Manyatta B

The poor condition of these structures significantly hampers accessibility, as movement between different points within the settlement is often disrupted when flooding occurs or during heavy rainfall. This vulnerability underscores the necessity for improved infrastructure to enhance connectivity and ensure the safety of residents in the face of climate impacts.

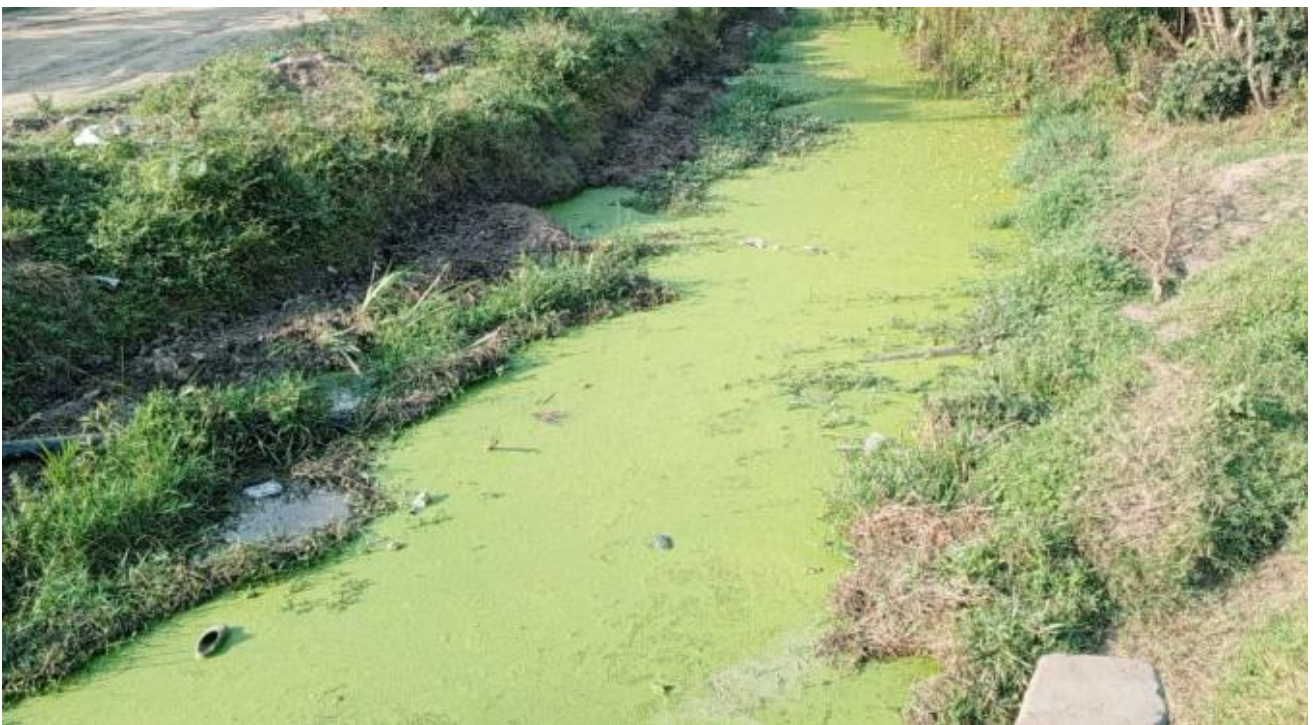
Figure 27: Image depicting Liquid waste disposal in a river

Consequently, liquid waste is often discharged into open drains and directly into Rivers Auji and Nyamasaria, posing serious public health risks and contributing to the spread of waterborne diseases such as cholera and dysentery, especially during flooding events. The encroachment of riparian lands exacerbates water contamination, accentuating the community's vulnerability to climate change impacts.

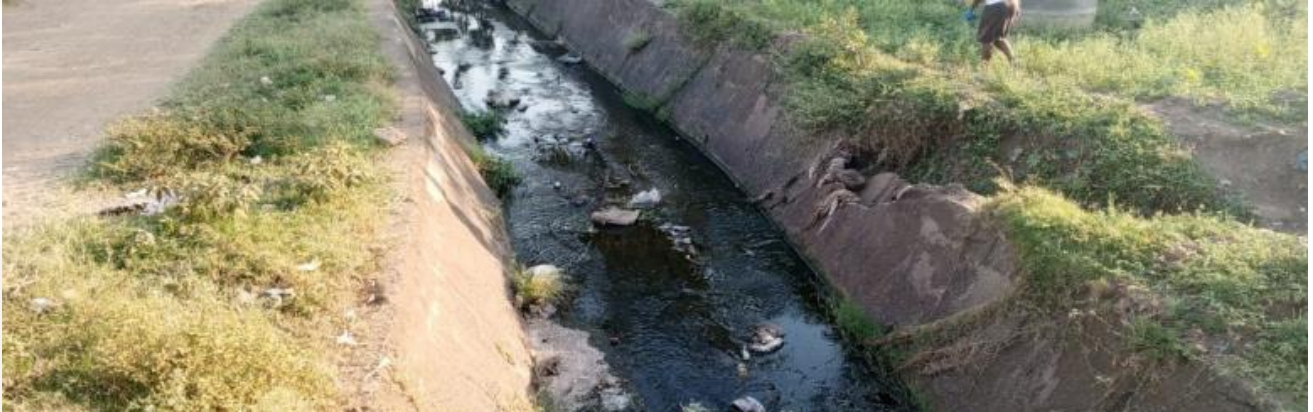
Figure 28: Image of blocked drainage facility

In Manyatta B, stormwater management poses a significant concern, driven by the settlement's geographical and environmental characteristics. Majority of the storm water from Kisumu City drains into Manyatta B, given that it is part of the lowest elevation sites of Kisumu city.

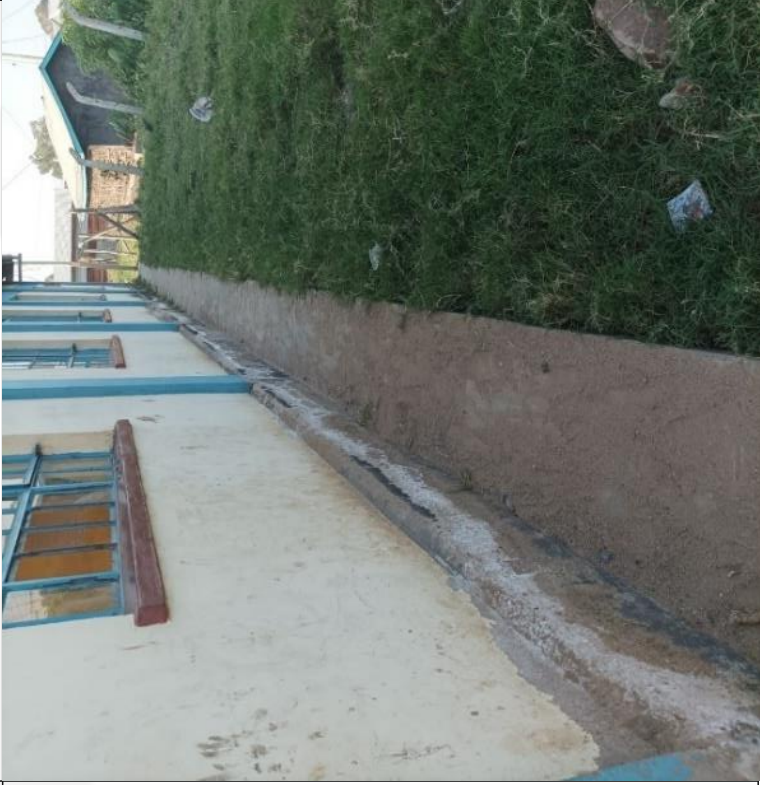
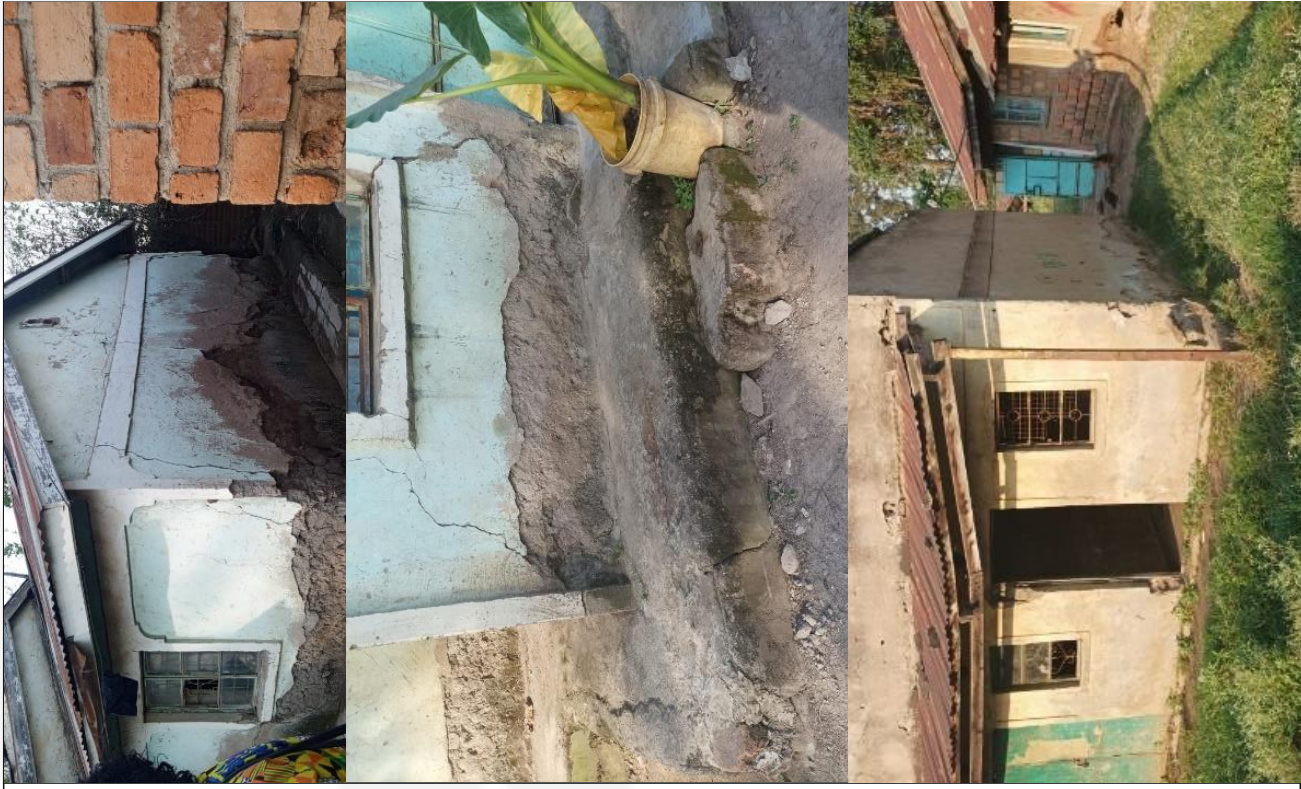
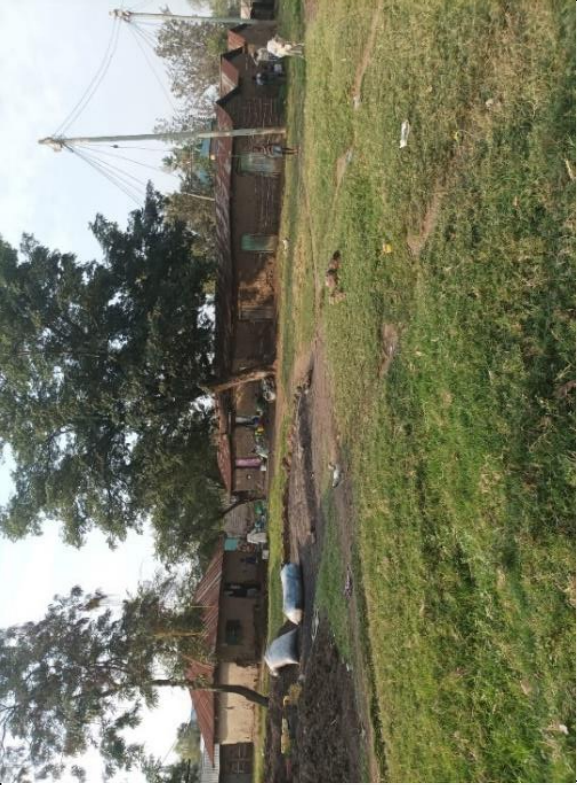
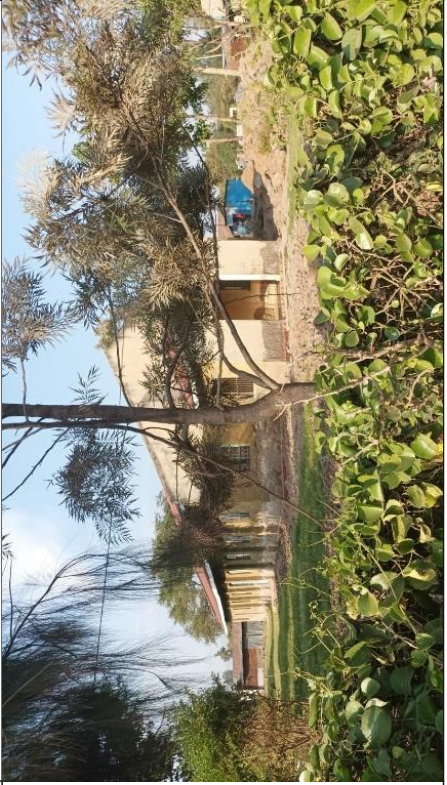
Thematic area	Sector	Losses and damages	Manifestations of the damages	Images
Social sectors	Health	1 health facility partially destroyed · Kuoyo health facility, level 3 facility	a) The hospital developed cracks b) The hospital exterior painting was destroyed

Education	5 education facilities partially destroyed and 1 fully destroyed (Bridge International School at Koyang'o) · Wandiege Primary School · Simon New	a) Complete destruction of the entire classes' structures b) Compound destruction c) Sewer and Drainages destruction d) Painting of the class walls e) School furniture partially destroyed

- At Kuoyo unit, most houses up to 96% semi-permanent are semi-permanent and this is where the houses were most affected.
- At Gesoko area, more of semi-permanent structures were destroyed as compared to the permanent units.
- At Lower Kanyakwar Unit, more Semi perma-

Housing	<p>nent structures destroyed as compared to the permanent units.</p> <ul style="list-style-type: none"> · At upper Kanyakwar more permanent structures were destroyed as compared to the semi-permanent structures.

Culture	<ul style="list-style-type: none"> · Grave sites were affected at Kuoyo, Upper and lower Kanyakwar.

Productive Sectors	Agriculture	Full and Partial destruction of vegetable gardens at households. · Poultry fully and in some instances partially destroyed.		
	Industries	1 industry partially damaged CFAO Kenya	The walls and compound of the facility was destroyed. Some of the vehicles were partially damaged.
